Xanadu Condominium Association, Inc.
750 North Atlantic Avenue
Cocoa Beach, FL 32931

**Existing Building Condition Survey
and Observation Report**

March 15, 2023

RE: Xanadu Condominium – Milestone Inspection Report
750 North Atlantic Avenue Cocoa Beach, FL 32931
KEG File # 18RD-0657

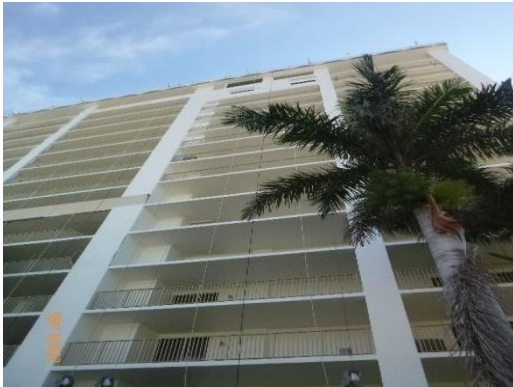
Photo 1: West side and front of the building.

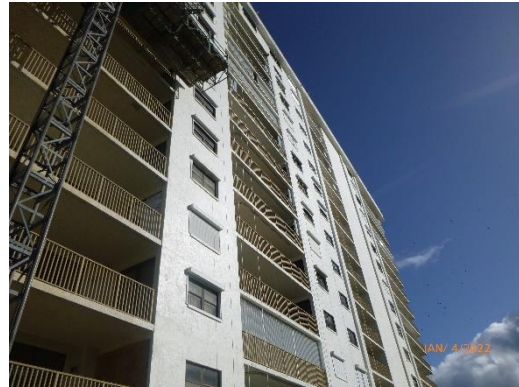
Photo 2: South side of the building.

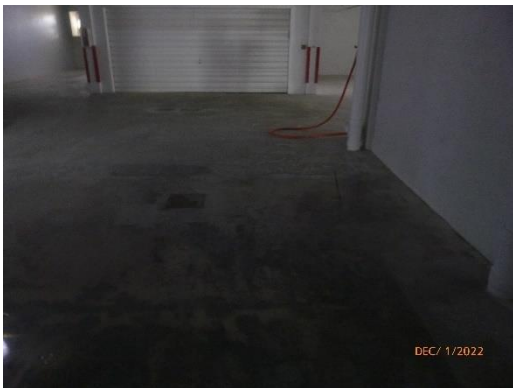
In addition to no severe cracks, no concrete spalls were observed throughout the building. Concrete spalls throughout the whole building had been recently repaired as part of the current restoration project. Concrete spall in the underground parking garage had been recently repaired as part of the current restoration project. From our understanding, no concrete spalls were found at the balconies since they have been repaired as part of the current restoration project.

Photo 3: Concrete repairs at underground parking garage.

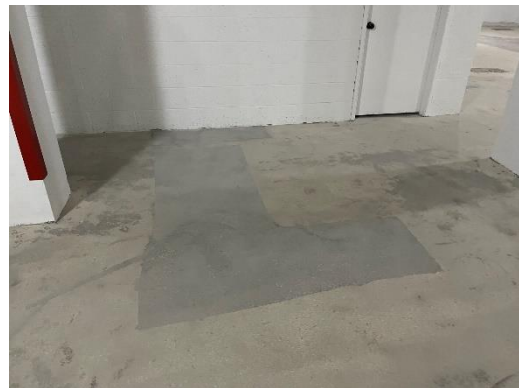
Photo 4: Concrete repairs at underground parking garage.

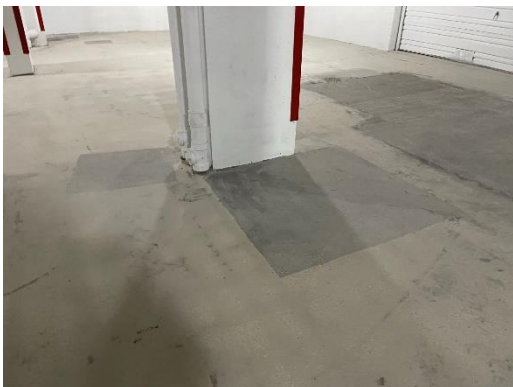
Photo 5: Concrete repairs at underground parking garage.

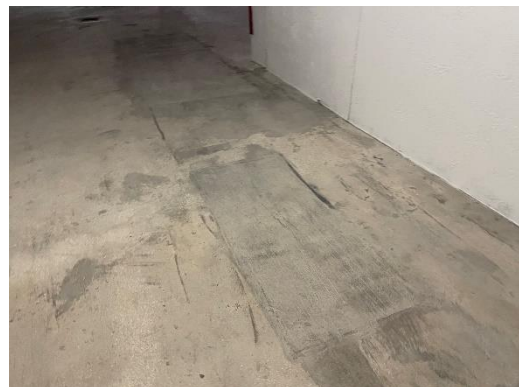
Photo 6: Concrete repairs at underground parking garage.

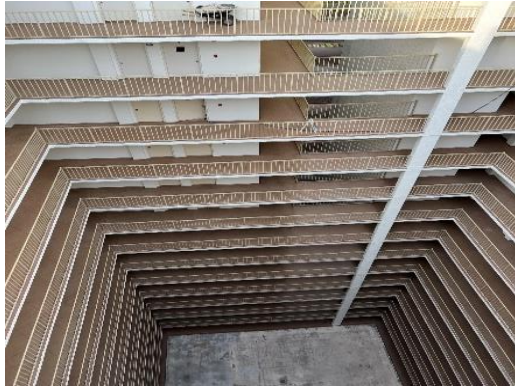
Photo 7: Inside, exterior walkways at North side.

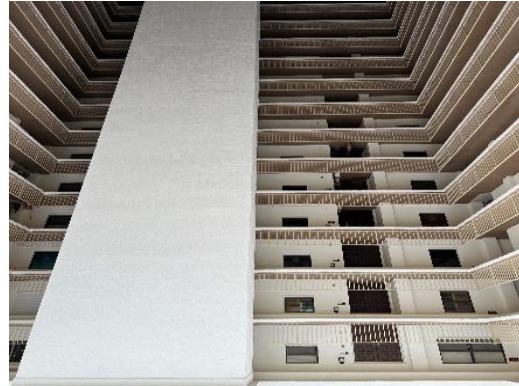
Photo 8: Inside, exterior walkways at East side.

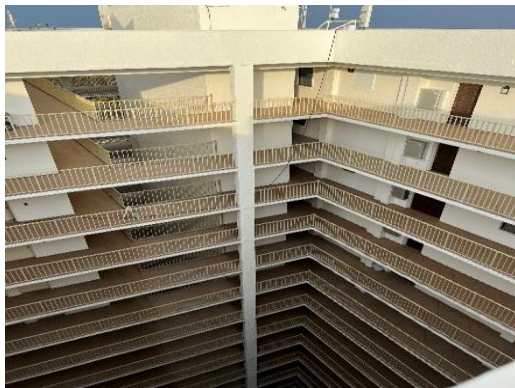
Photo 9: Inside, exterior walkways at South side.

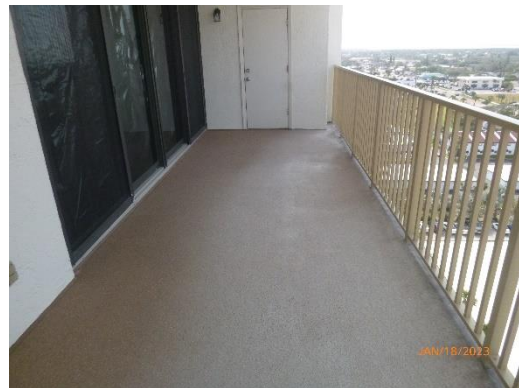
The condition of the deck coating on the balconies and walkways are in good condition due to the replacement and recoating done during the restoration project. Some balconies, however, have tile installed on the floor.

Photo 10: Balcony with replaced deck coating.

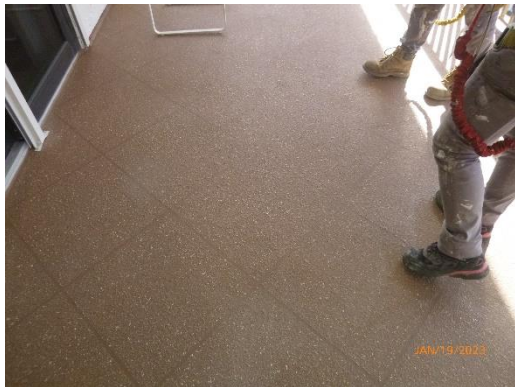
Photo 11: Balcony with replaced deck coating.

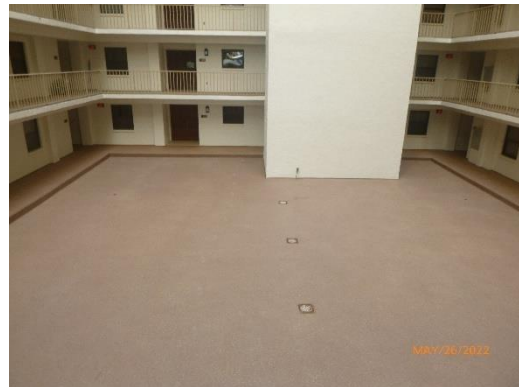
Photo 12: Deck coating installed at atrium.

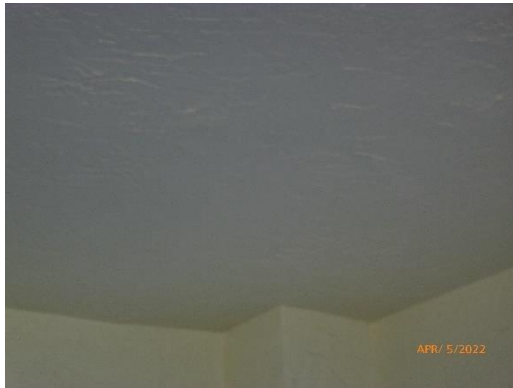
Overall, the condition of the exterior paint is good, the building has been repainted as part of the restoration project. No peeling paint was observed throughout the building, or large paint bubbles were observed at balcony ceilings.

Photo 13: Painted ceiling at balcony.

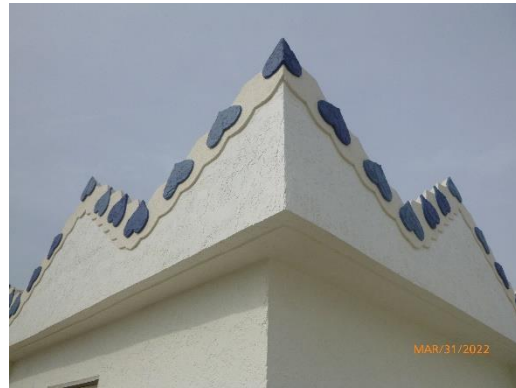
Xanadu has a flat roof with iso boards and tapered roof. At the roof there are two additional structures for the elevator, and staircases with flat roof as well. The roof is accessed through a staircase on the PH floor. All roof areas, the main roof and two additional roof buildings, show signs of deterioration and have exceeded its useful life. We recommend all roof areas have their existing roof coverings completely removed, stripped down to expose the concrete deck, shall have all existing vents replaced, all drip edge, flashings replaced, and a new roof system shall be installed.

Photo 14: Painted roof structure.
